ENGINEERING STUDY OF SELECTED LOCATIONS EXPERIENCING HIGH ACCIDENT FREQUENCY UNDER SNOWY AND ICY ROADWAY CONDITIONS

PREPARED BY
PROJECT PLANNING SECTION
PLANNING AND RESEARCH BUREAU
ENGINEERING DIVISION
MONTANA DEPT. OF HIGHWAYS

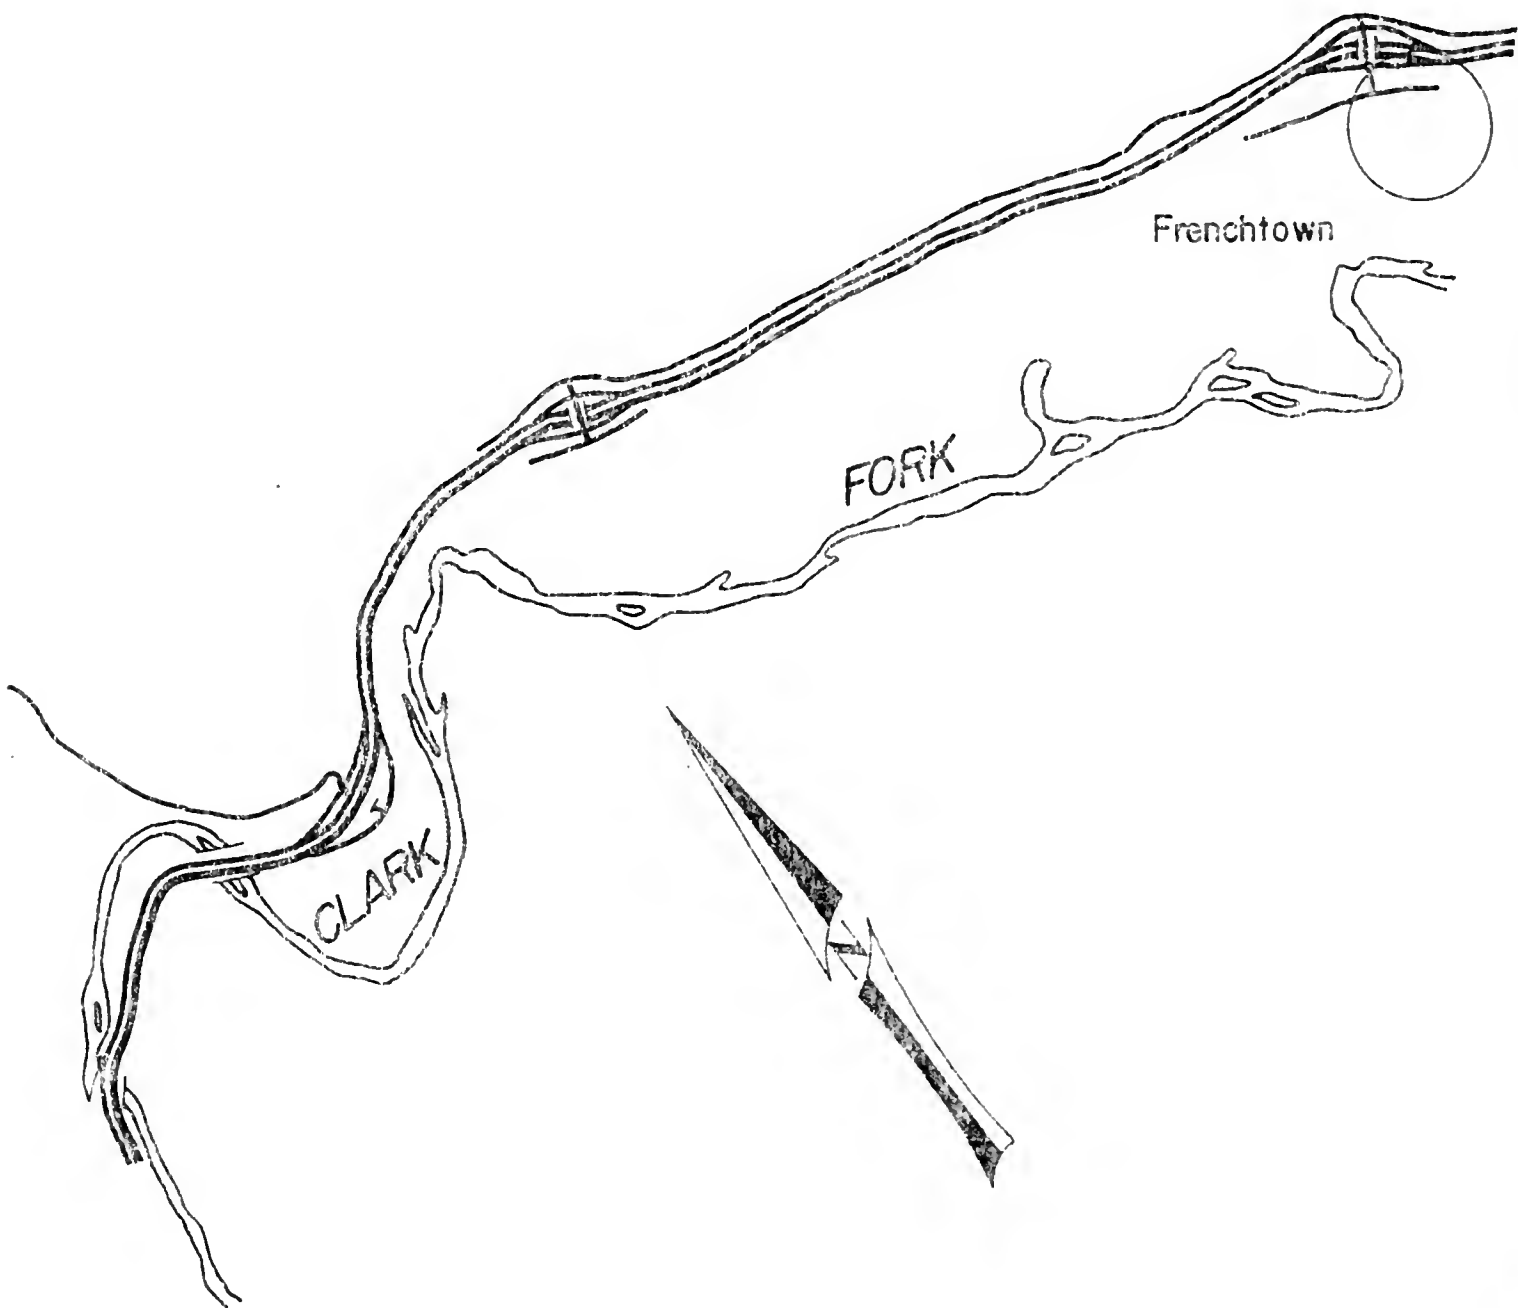
MILEPOST 80 - MILEPOST 90

General: The Study area is a 4-lane section with concrete driving lanes and asphalt shoulders. At Milepost 80 - 82 a recently completed add two lanes project was opened to the driving public in 1979. The section traverses fairly level terrain.

Comment: Accident experience for this section was misplaced, therefore is not reflected on the adjoining map. A clustering of accidents has occurred at approximately Milepost 82 on a verticle curve. A clustering of accidents has also occurred on a curve section at Milepost 88.5⁺ and at the Frenchtown Interchange at Milepost 89.5⁺.

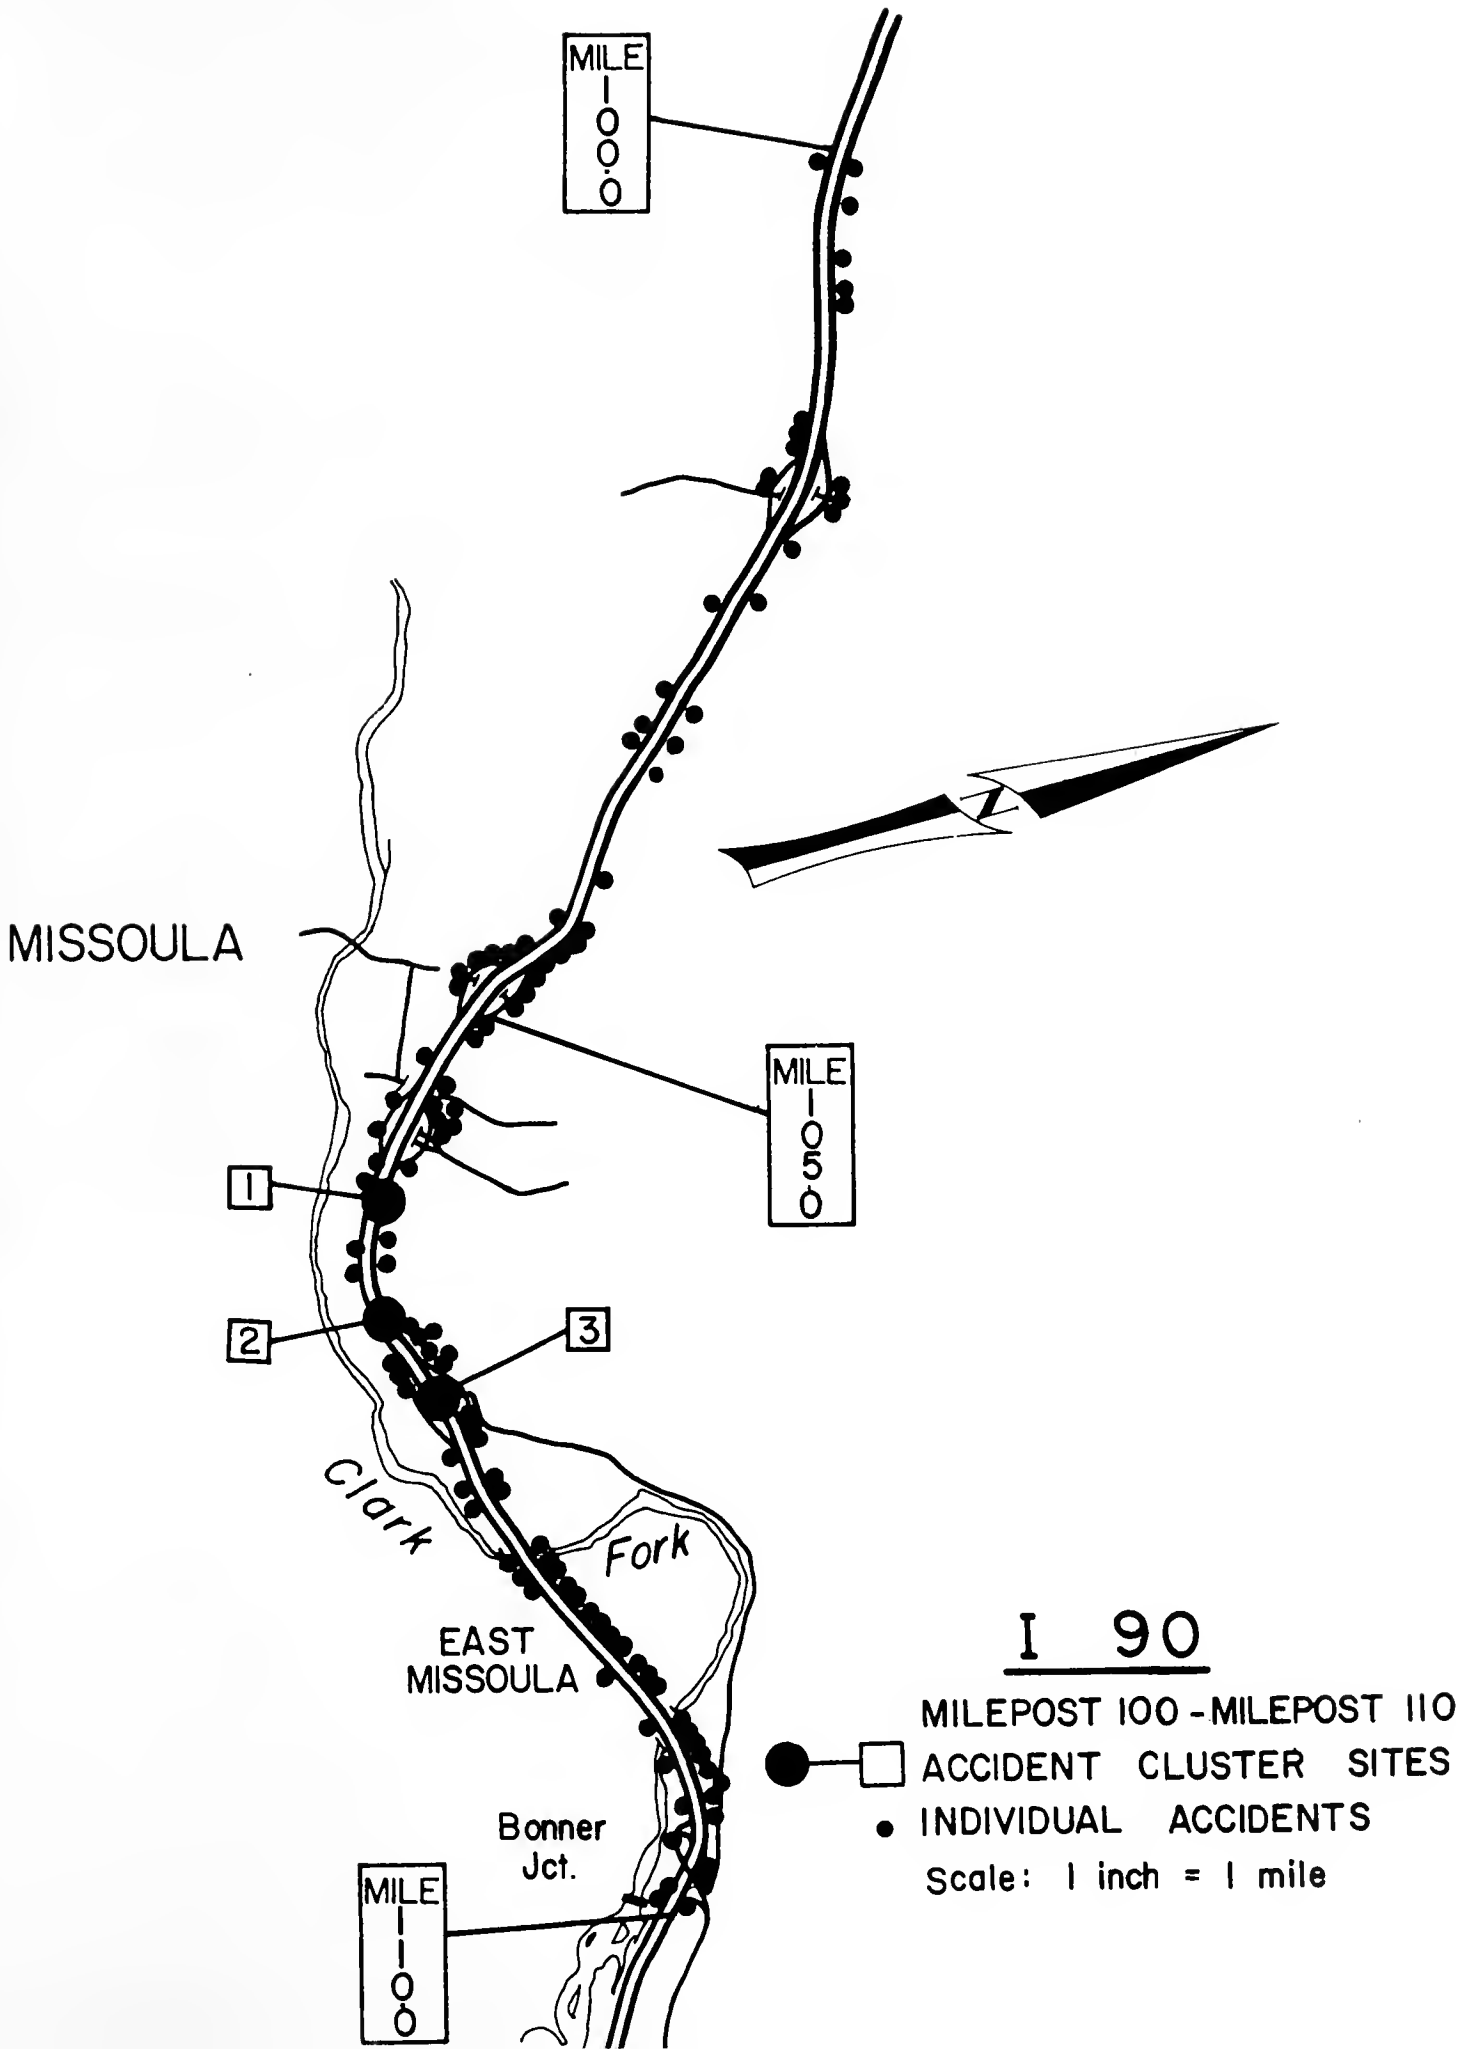
ACCIDENT CLUSTER DETAIL
I 90 MP 100 - MP 110

General: This study area extends through the city of Missoula. Numerous interchanges and high traffic volumes are present. The roadway was constructed in 1966 with the driving surface PCC Concrete.

Comments: Accident frequency is scattered throughout the section with a buildup at or near the interchanges.

7 Accidents total
57% Eastbound
71% Icy or Snowy
57% Dark

10 Accidents total
10% Eastbound
90% Icy or Snowy
10% Dark

12 Accidents total
50% Eastbound
8% Icy or Snowy
50% Dark

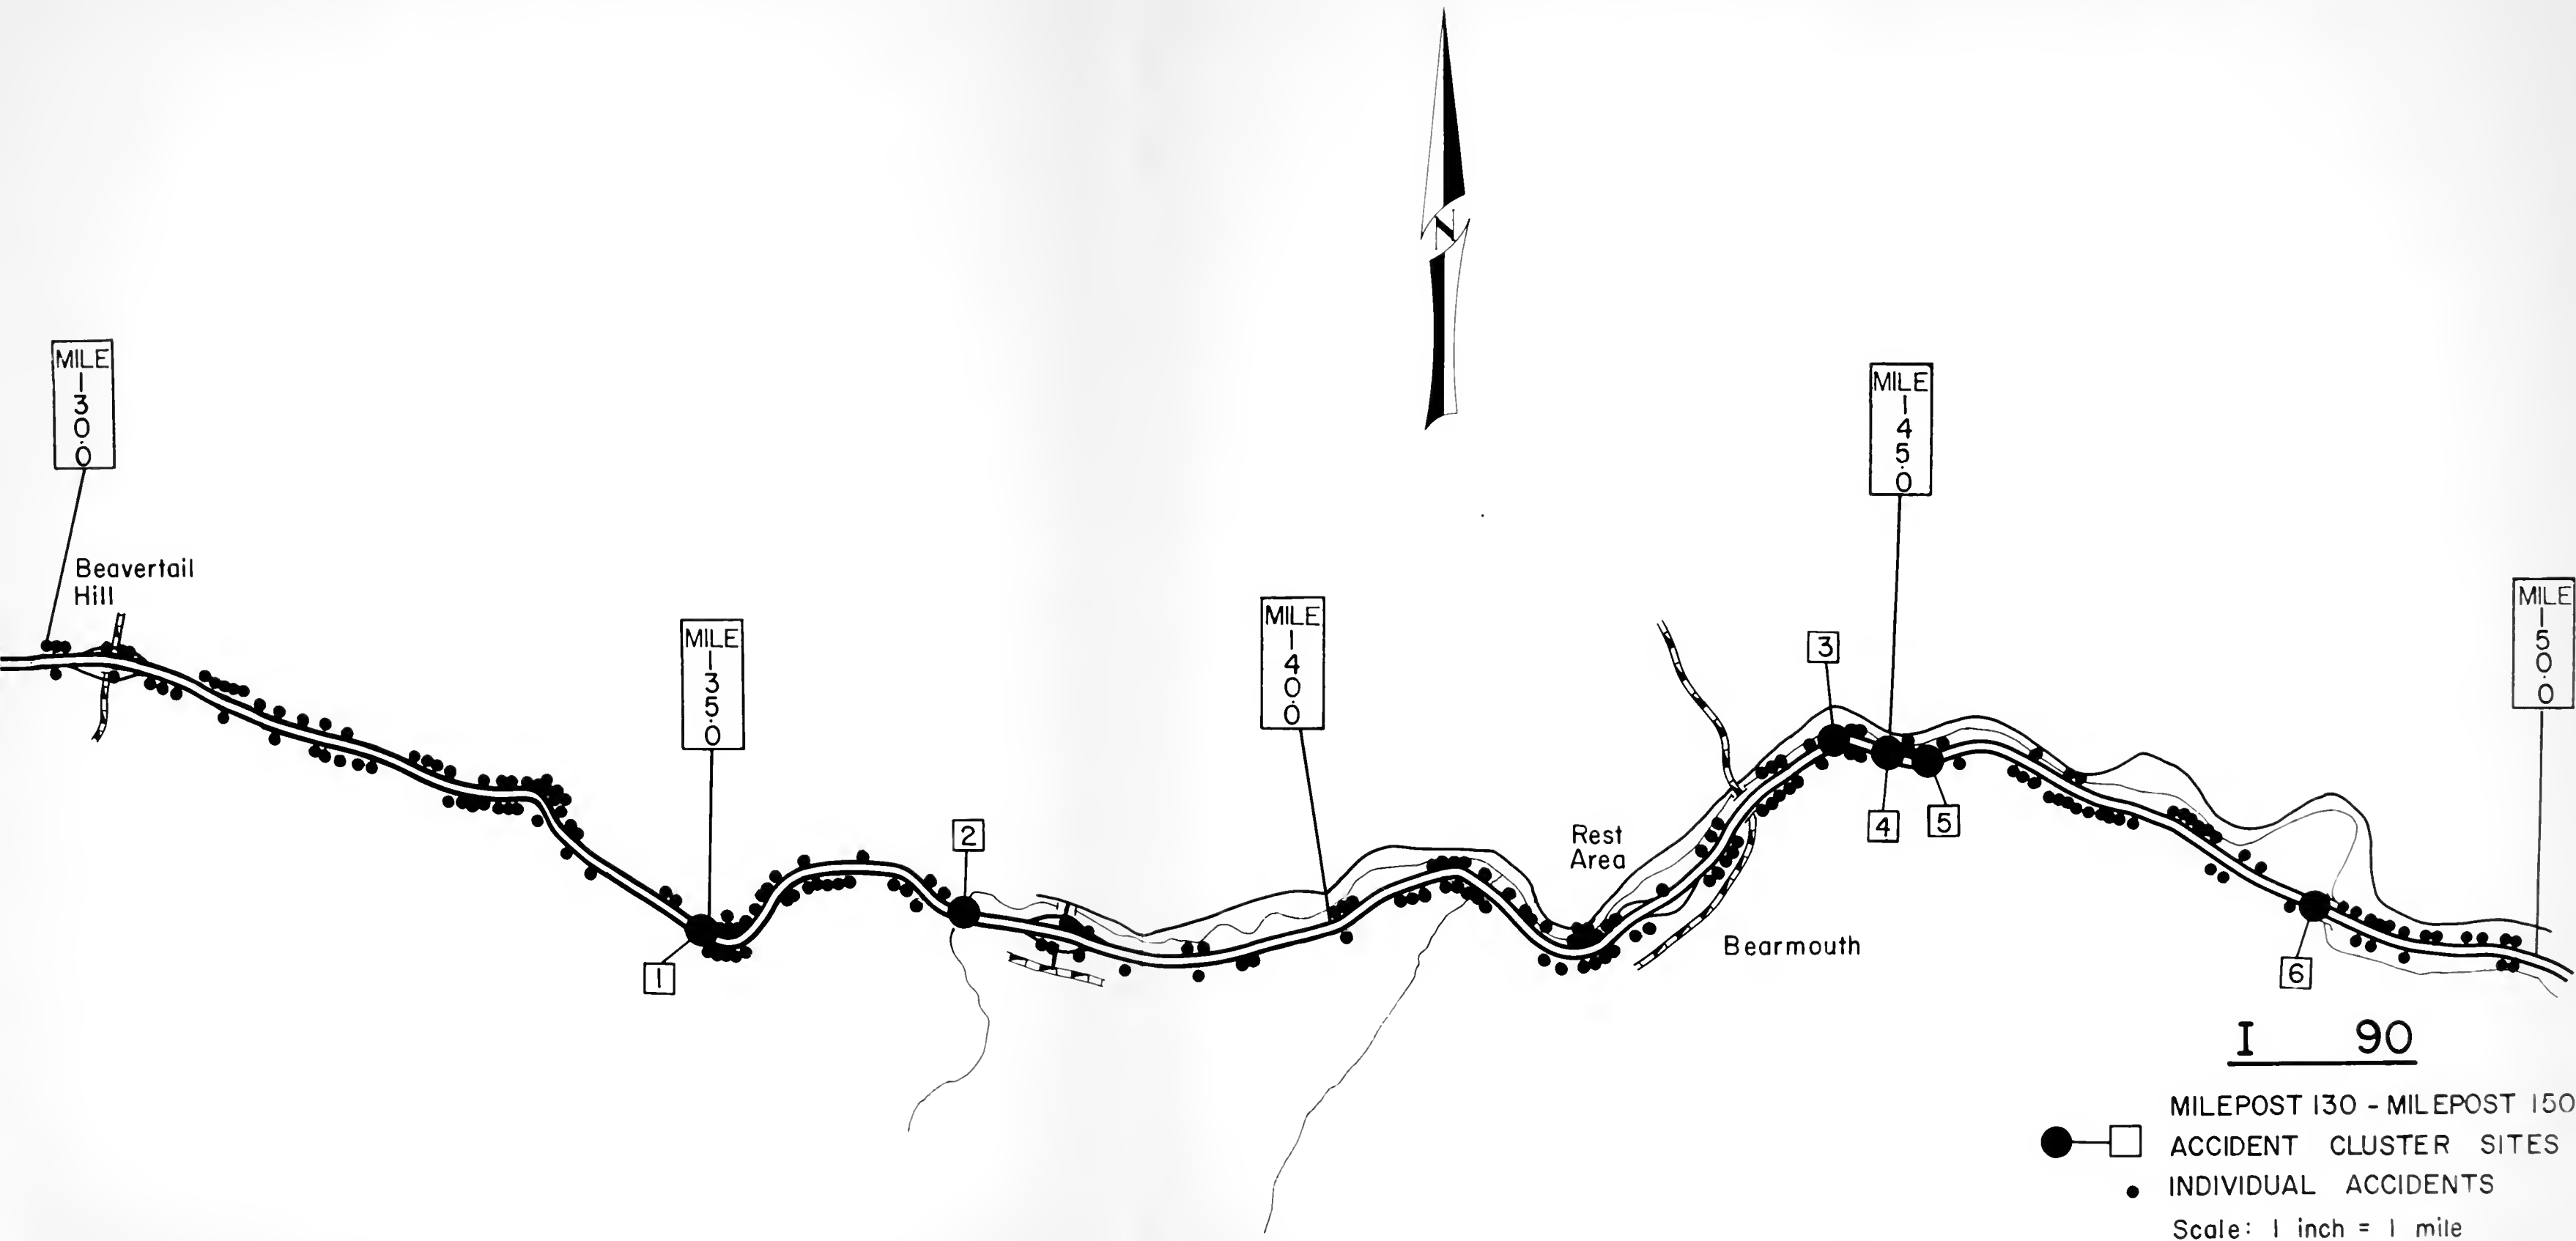
ACCIDENT CLUSTER DETAIL
I 90 MP 130 - MP 150

- General: This study section contains two 10-mile contiguous sections. Various construction years to complete the four-lane facility took place. The entire 20-mile section has a plant mix surface treatment.
- Comment: Accident frequency is spread throughout the study area. Several clusters of accidents were noted primarily on curve sections and at bridges. A safety project at Milepost 145+ entailed concrete median barrier and was near the Bearmouth Rest Area. A nearby hot water spring instigated foggy and icing conditions. This improvement has substantially reduced accident frequency and severity at this location.

10 Accidents total
70% Eastbound
90% Icy or Snowy
50% Dark

9 Accidents total
67% Eastbound
78% Icy or Snowy
22% Dark

8 Accidents total
63% Eastbound
88% Ecy or Snowy
0% Dark

12 Accidents total
100% Eastbound
83% Icy or Snowy
17% Dark

10 Accidents total
20% Eastbound
70% Icy or Snowy
30% Dark

12 Accidents total
50% Eastbound
58% Icy or Snowy
33% Dark

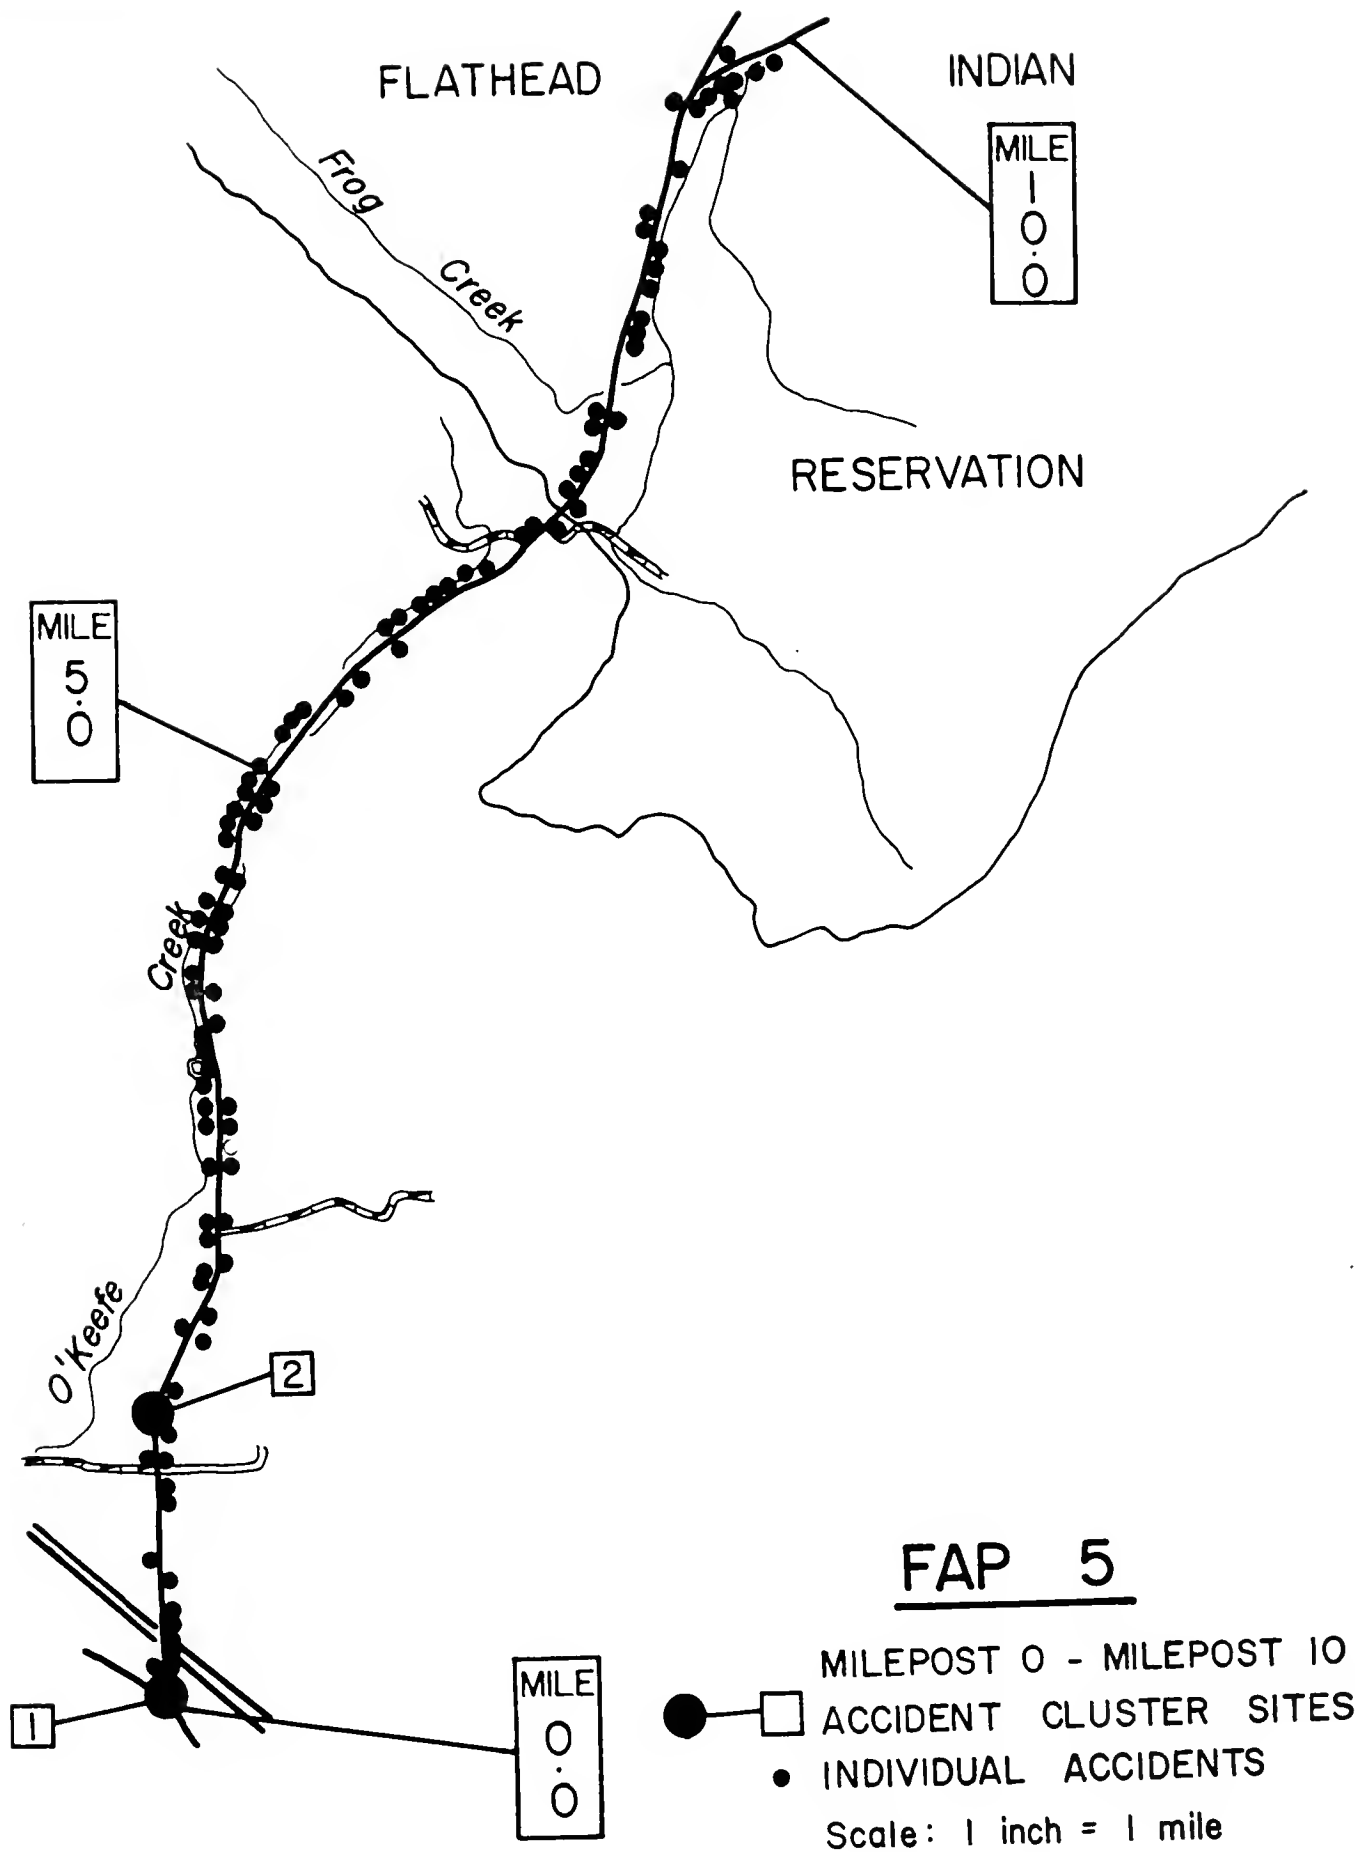
ACCIDENT CLUSTER DETAIL
FAP 5 MP 0 - MP 10

General: The area begins on US #93 at its junction with I-90 at the DeSmitt Interchange and proceeds north for 10 miles. Numerous safety projects have been constructed on this section including roadway widening at the truck stop and slope flattening and delineation on some curves.

7 Accidents total
43% Northbound
29% Icy or Snowy
29% Dark

5 Accidents total
20% Northbound
20% Icy or Snowy
40% Dark

Comments: A safety project to provide slope flattening and delineation on a curve approximately Milepost 2, is tentatively scheduled for letting of January 1981.

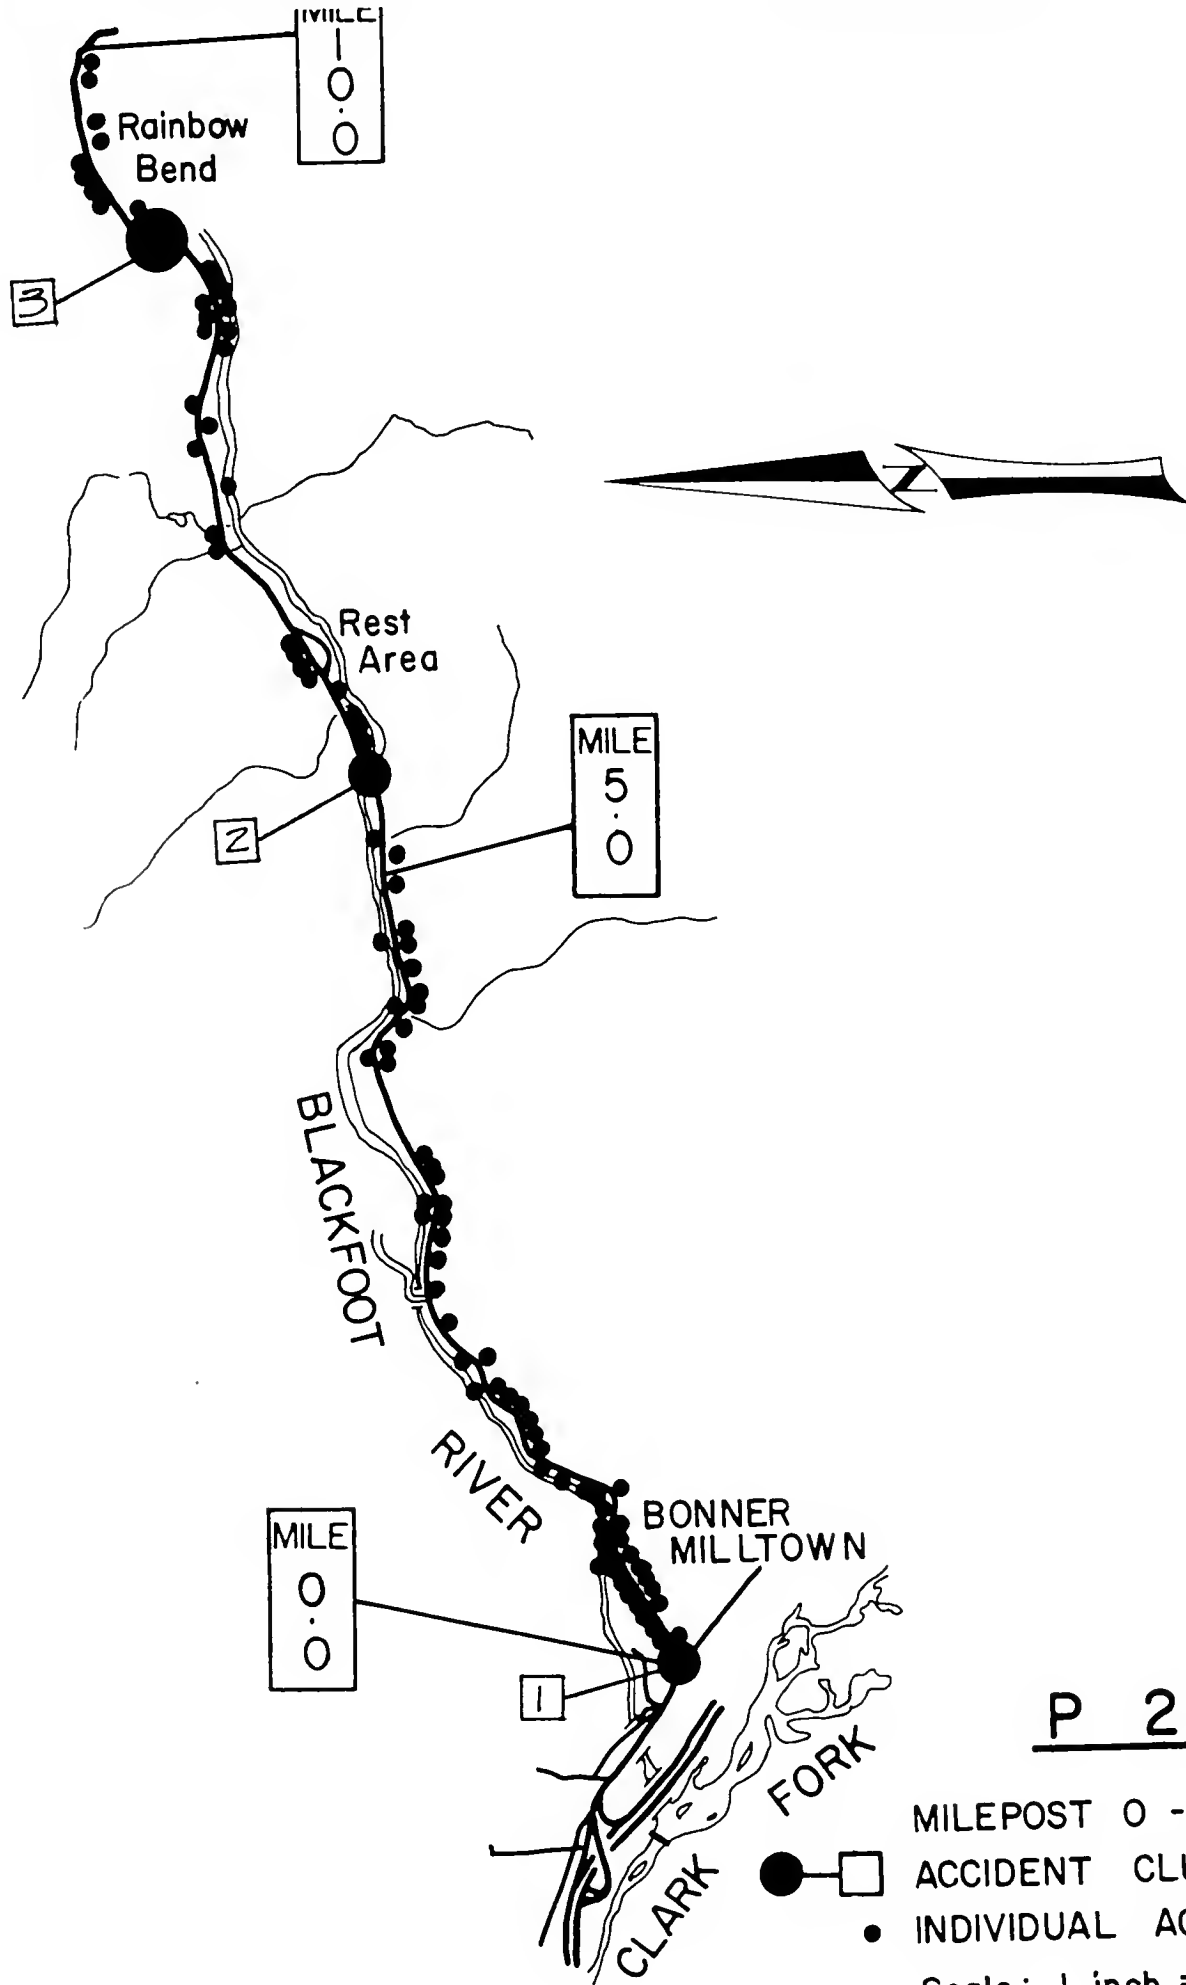
MILEPOST 0 - MILEPOST 10
● ACCIDENT CLUSTER SITES
• INDIVIDUAL ACCIDENTS
Scale: 1 inch = 1 mile

General: The section begins near the Interstate 90 Bonner Interchange at Bonner and traverses the Blackfoot River East. Construction periods vary through the section. The beginning portion was constructed or altered to provide interstate connections. The easterly portion is basically old road with numerous curves.

Comment: Accident history is concentrated at the beginning of the route and at a curve section commonly known as Rainbow Bend. A safety project is in the planning stage for this area. Also special side of the road delineation was placed in this area to provide positive guidance around the sharp curves.

12 Accidents total
50% Eastbound
33% Icy or Snowy
33% Dark

5 Accidents total
40% Eastbound
40% Icy or Snowy
20% Dark

21 Accidents total
43% Eastbound
14% Icy or Snowy
24% Dark

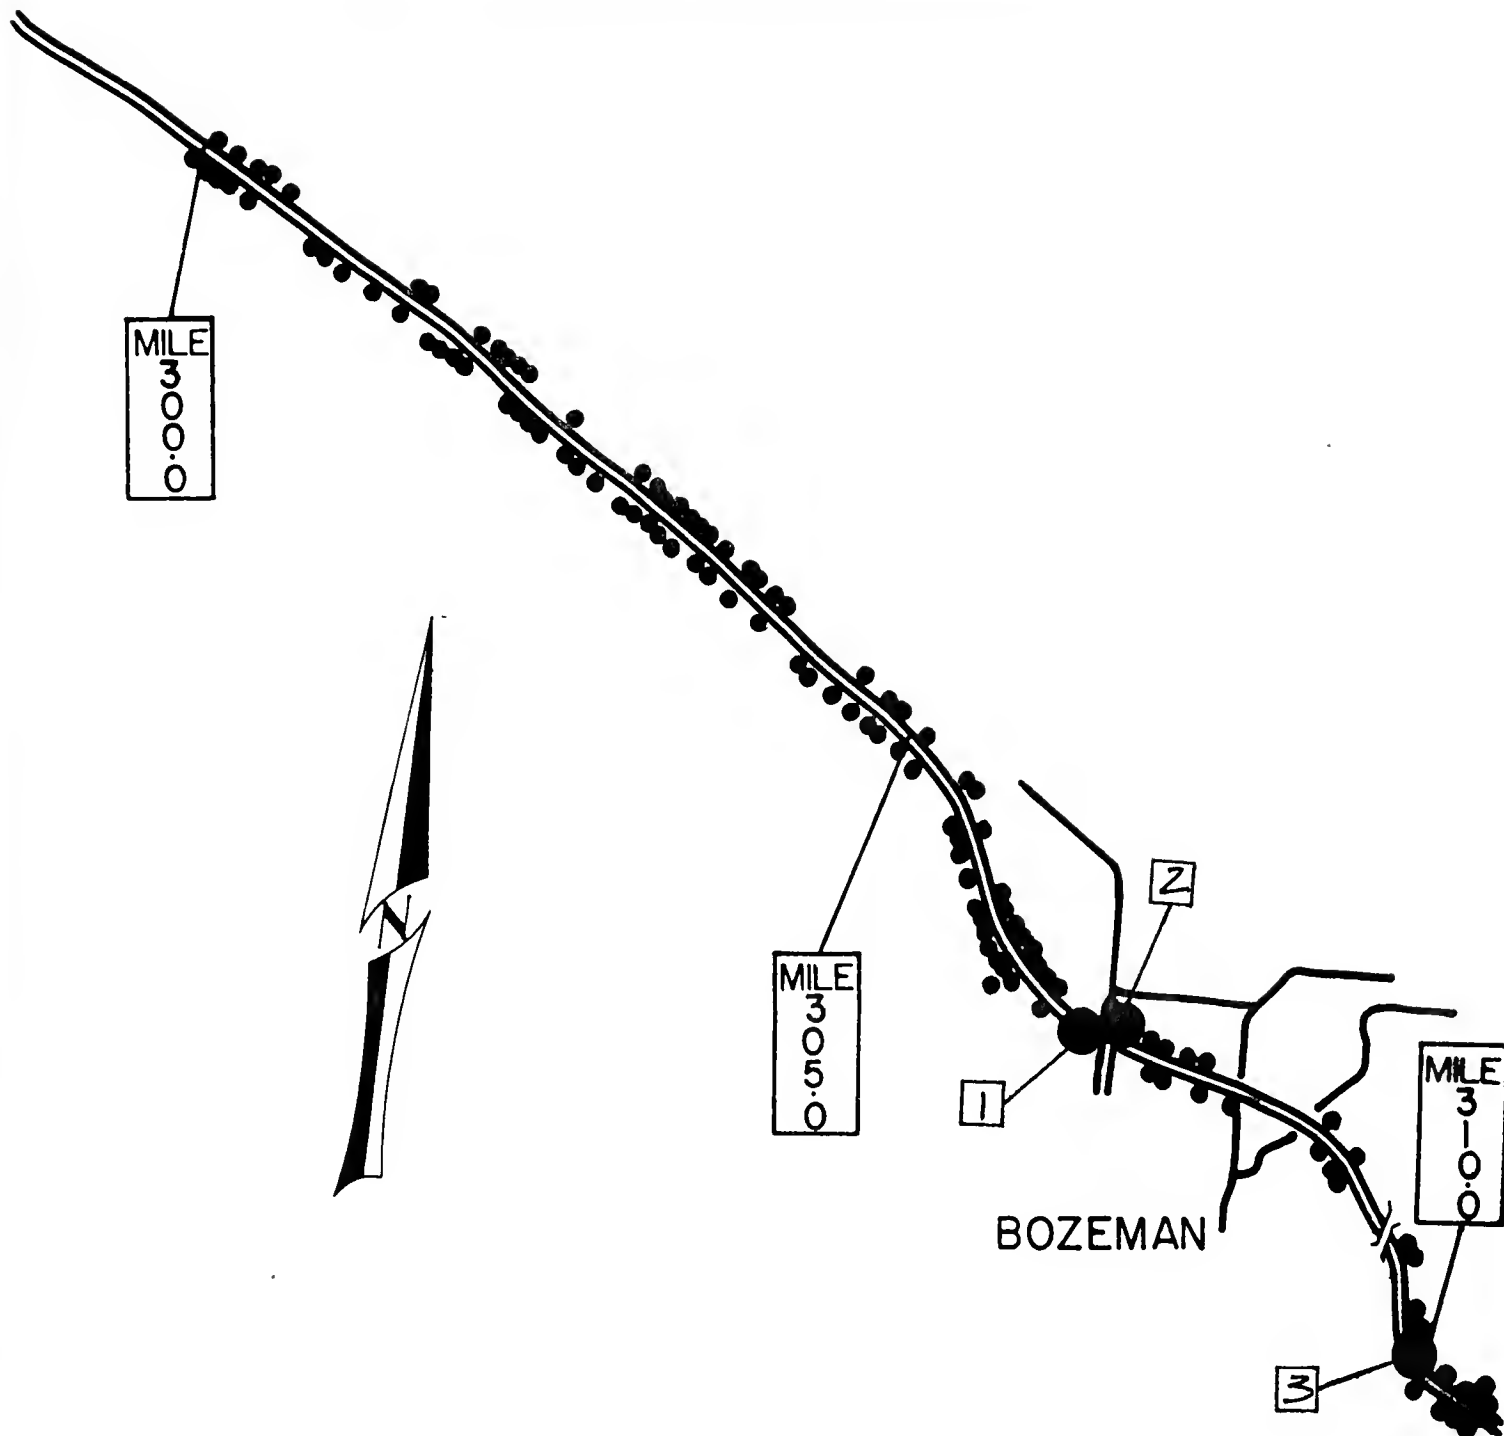
- — □ MILEPOST 300 - MILEPOST 310
● ACCIDENT CLUSTER SITES
● INDIVIDUAL ACCIDENTS

General: The 4-lane facility, built in the late 60's - mid early 70's has a plant mix surface treatment with a V-ditch median on the majority of the section. Concrete driving lanes with asphalt shoulders are present at the beginning of the study section.

Comment: Accident occurrence is spread throughout the study area with clusters of accidents occurring at the West Bozeman Interchange and East of Bozeman on a curve section.

11 Accidents total
82% Eastbound
55% Icy or Snowy
9% Dark

15 Accidents total
0% Eastbound
53% Ecy or Snowy
40% Dark

12 Accidents total
58% Eastbound
67% Icy or Snowy
42% Dark

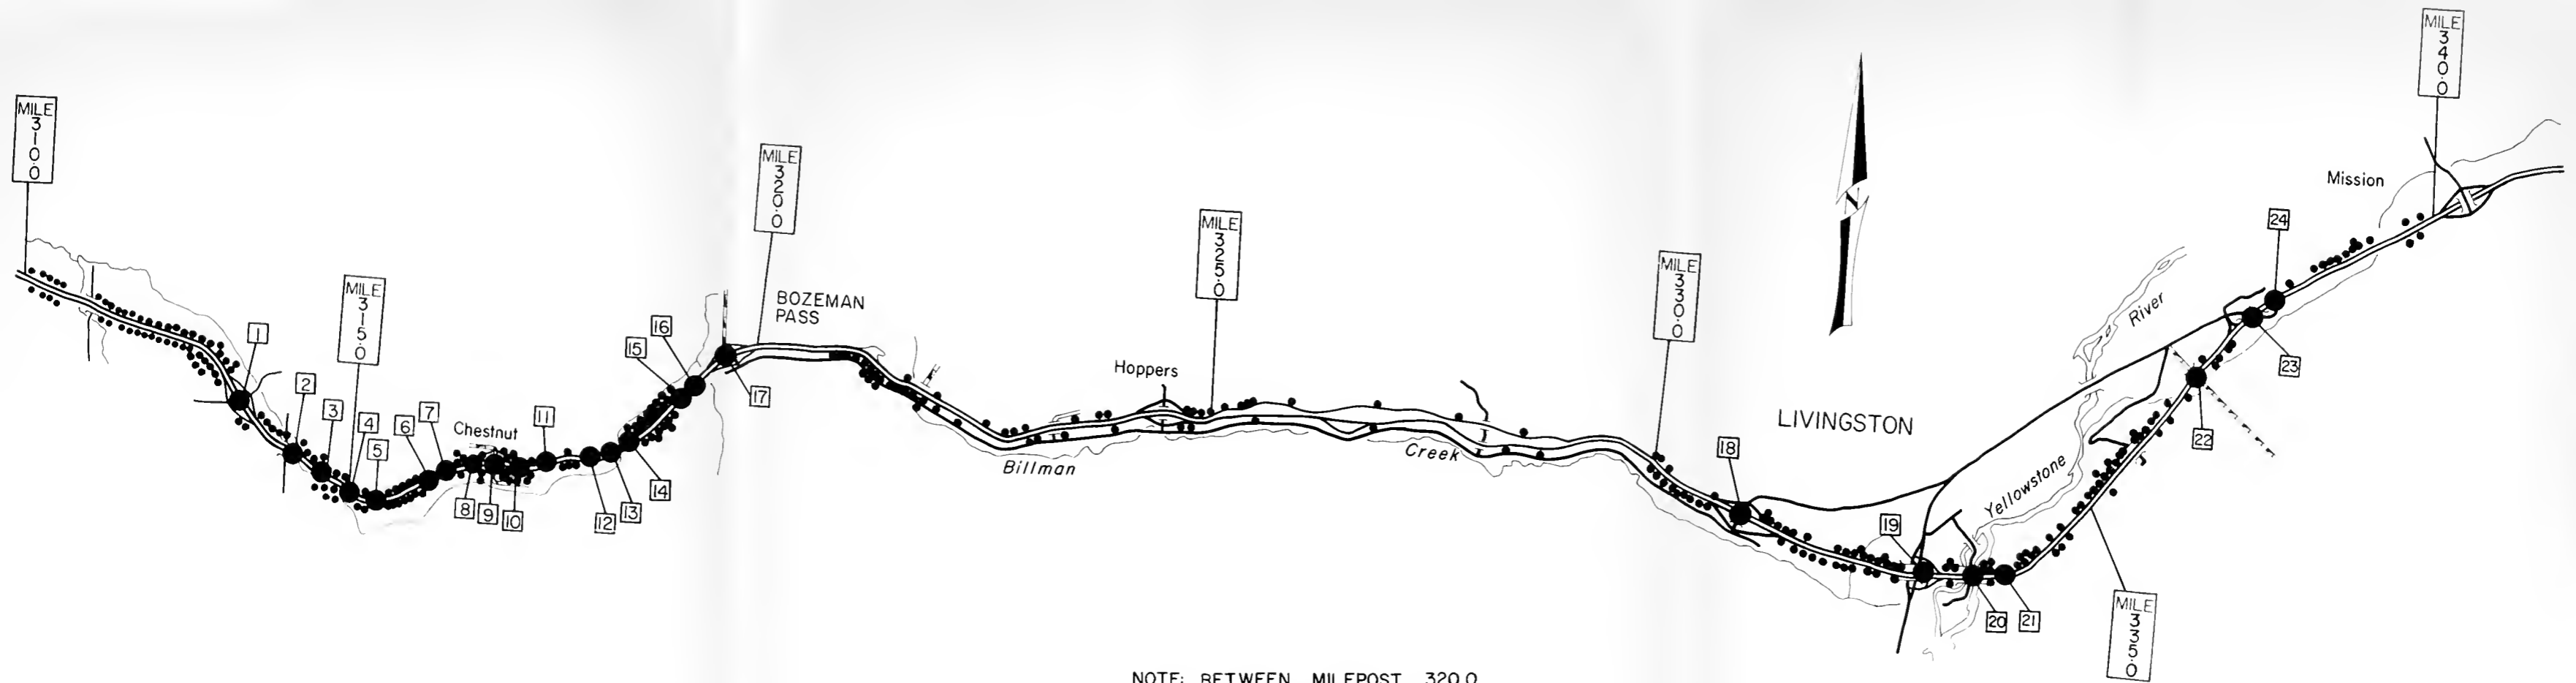
- MILEPOST 310 - MILEPOST 340
- ACCIDENT CLUSTER SITES
- INDIVIDUAL ACCIDENTS
- Scale: 1 inch = 1 mile

General: This area includes three study areas contiguously and begins on the East urban limits of Bozeman traverses Bozeman Pass and ends near the Mission Interchange East of Livingston. The area at particular locations experience very high wind velocity causing limited visibility and snowdrifting during winter months.

Comment: A high incidence of accident occurrence has happened with numerous clusters on the west slope of Bozeman Pass to Bozeman. Several clusters of accident also exists in the Livingston area. A Wyoming type snowfence was installed, utilizing safety funds, at various locations near Livingstone.

NOTE: BETWEEN MILEPOST 320.0
AND MILEPOST 330.0 IT
IS NEW CONSTRUCTION. ONLY
2 YEARS DATA.

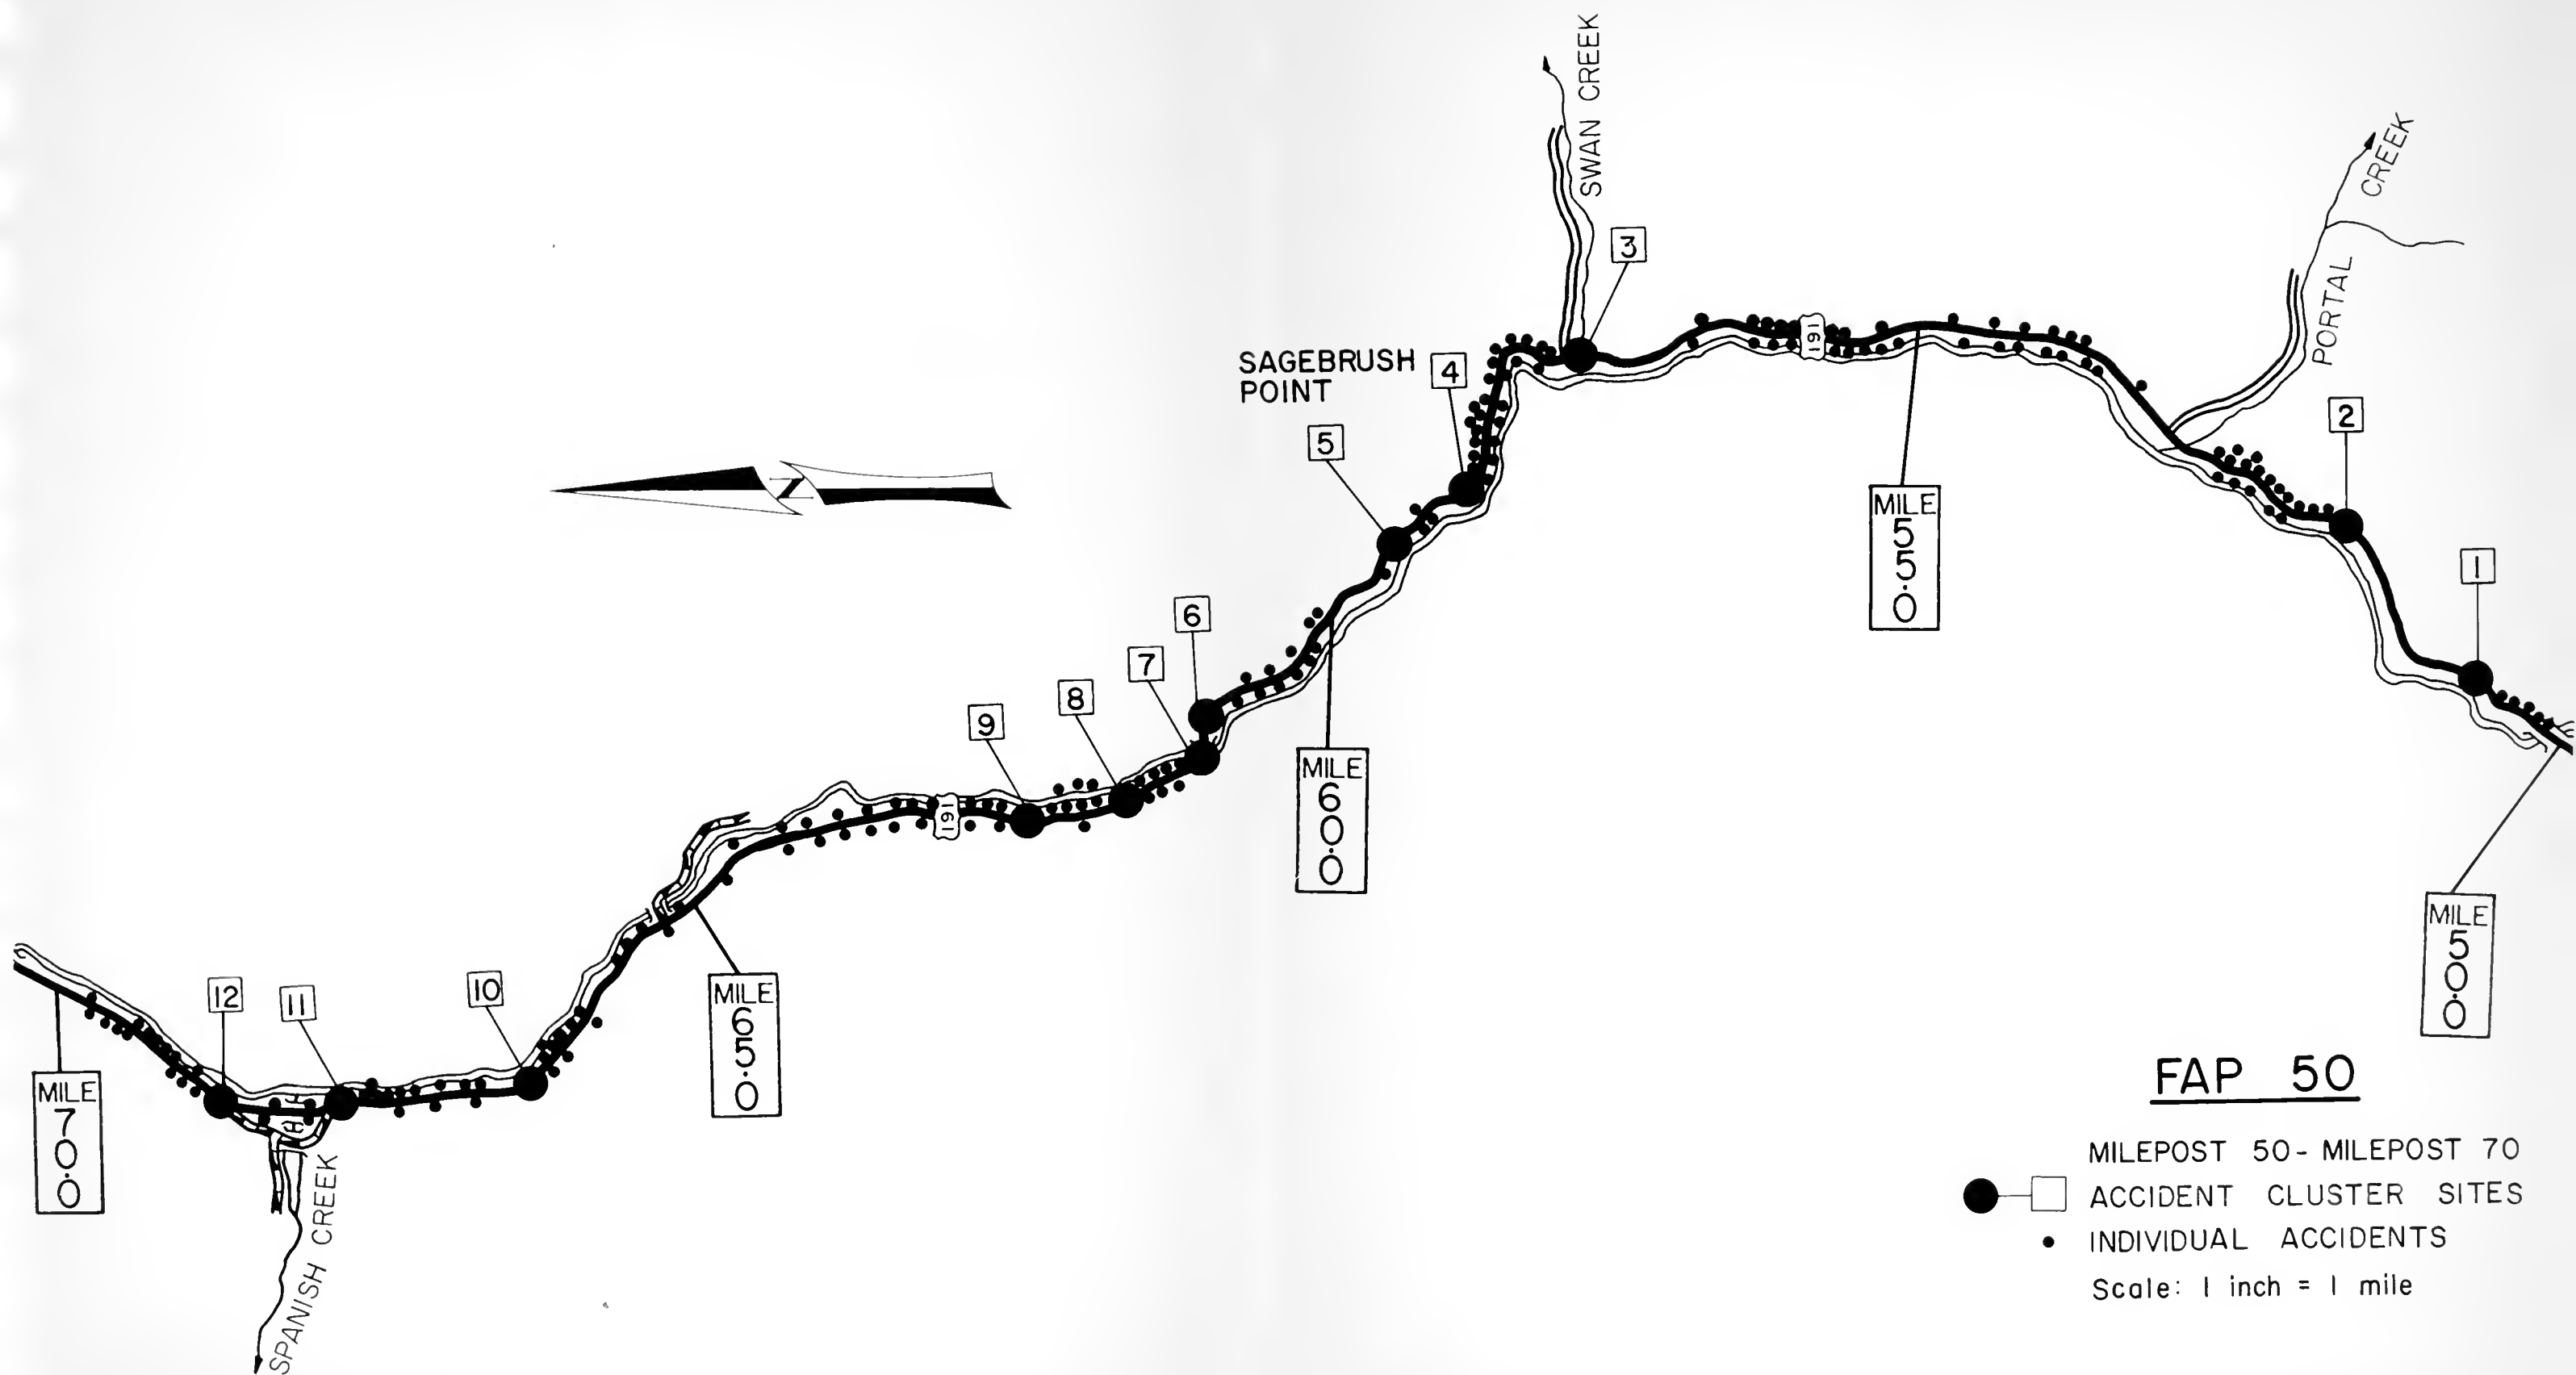
ACCIDENT CLUSTER DETAILS
FAP 50 MP 50 - MP 70

General: This Federal Aid Primary System Roadway parallels the Gallatin River between Yellowstone Park and Bozeman. This scenic highway experiences high volume tourist traffic entering Yellowstone National Park. The roadway, built in the 50's and 60's traverses heavily timbered mountainous terrain.

Comment: Accident experience is spread throughout the study area with numerous clusters of accidents generally located on curve sections. A safety project to install safety corrections such as guardrail roadway widening and an impact attenuator was installed in 1978 between Milepost 56 - 63. The safety corrections have not impeded snow removal. Accident experience shows a definite reduction after installation of the safety corrections. Special side of the road delineation at Milepost 50₊ - 51₊ installed on an experimental basis has shown a definite reduction in accidents.
